Manhole Inspection Summary

Manhole # S39I__046MH

Insp Date: **3/27/08 3:54 PM**

Location Address: **president st**

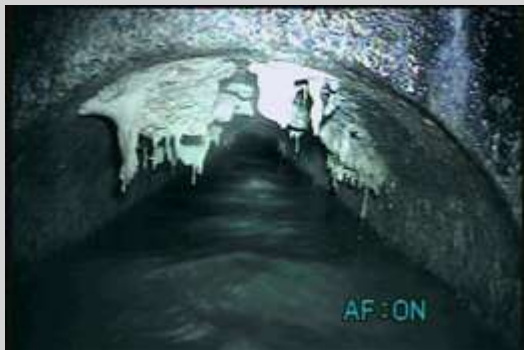
12 O'Clock Outflow

27 in. Circular Gravity Sewer
Pipe Out @ 12 O'Clock

Invert Depth: **18.92** (ft.) Flow Characteristics: **Fast**

Deposits: ☒ None ☐ Mud ☐ Sludge ☐ Debris ☐ Grease

Infiltration: **None** Pipe Seal Cond: **Unknown**

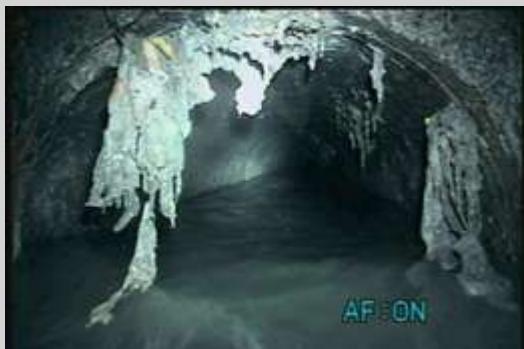
6 O'Clock Inflow

27 in. Circular Gravity Sewer
Pipe In @ 6 O'Clock

Infiltration: **None** Pipe Seal Cond: **Unknown**
